Public Health Assessment

Standard Chlorine Chemical Co. Inc. Kearny, Hudson County

CERCLIS # NJD002175057

Public Comment Release

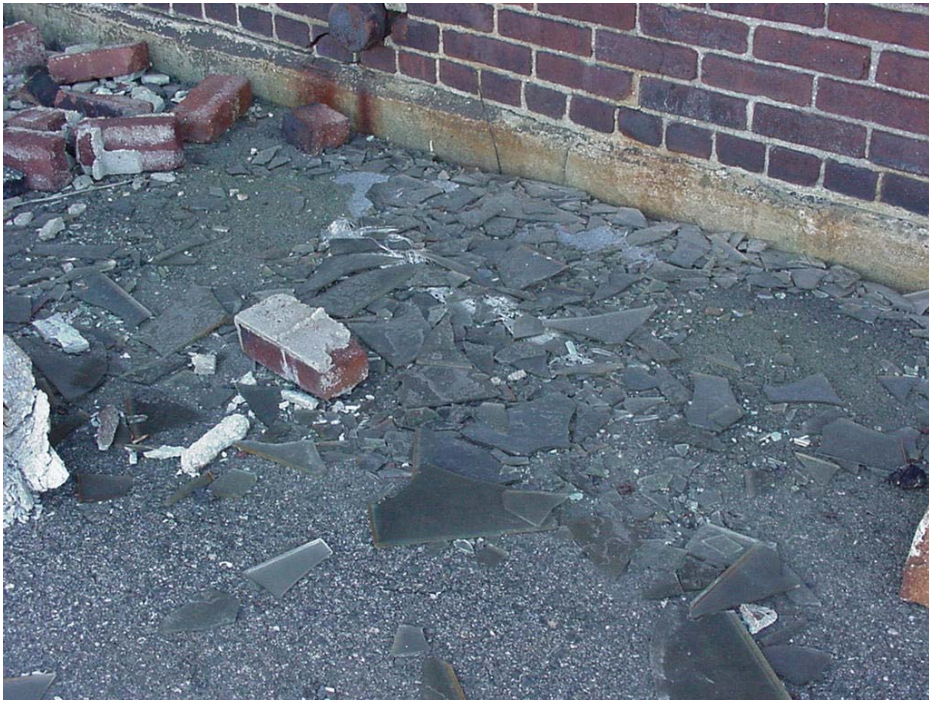
Photograph 1: Broken bricks and glass on the Standard Chlorine site

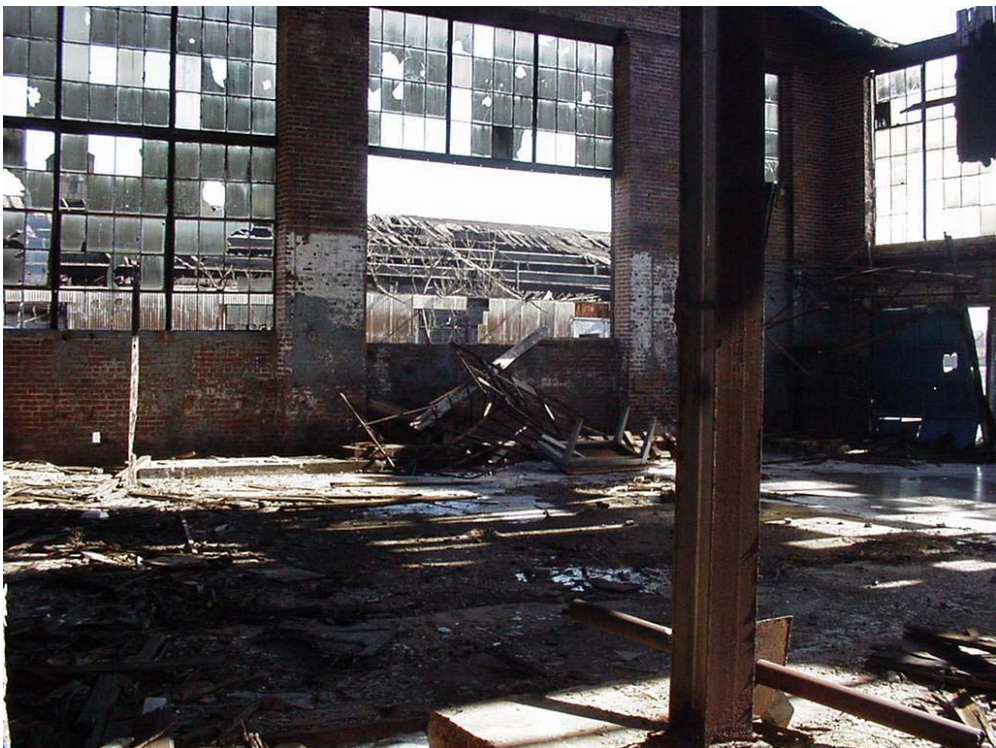
Photograph 2: Example of dilapidated building on the Standard Chlorine site

The site visit proceeded from this office building to an area where six sea boxes are stored, containing dioxin-contaminated asbestos and mixed organic wastes. Numerous physical hazards were present at the site including dilapidated buildings, broken windows, debris, and an open drainage ditch. Additionally, areas along the edge of the Hackensack River were littered with rubbish and debris. The site is mostly covered with asphalt, and in some sections, gravel. The asphalt and gravel caps were placed as part of interim remedial measures by the former Diamond Shamrock Company to address exposures associated with the COPR. A series of locked gates were encountered within the Standard Chlorine site. The lagoon system, located on the eastern part of the site, was visible from the Conrail right-of-way access road (Appendix A, see Figure 2). The area surrounding the lagoon system is enclosed by a six-foot high barbed wire fence. This fence is referred to as a "dust fence barrier" since it is lined with black tarp to reduce export of particles from the lagoon system area. A trench with standing water was observed inside the fenced area. The smell of naphthalene/moth balls was noted here. The southern boundary of the Standard Chlorine site was encountered which is comprised of an open drainage ditch that ultimately empties into the Hackensack River. This southern outfall into the Hackensack River was not visible from the fenced area near the lagoons. The drainage ditch had mixed standing and frozen water. *Phragmites australis* (or common reed), a wetland plant species, was observed on either side of the ditch. The former Koppers site was on the southern side of the drainage ditch and was observed to be marshy.

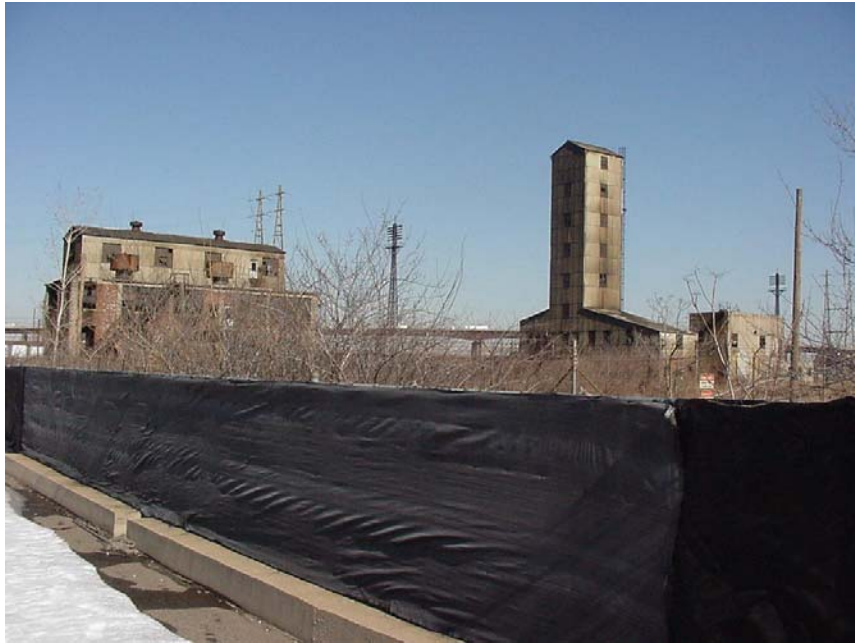
Photograph 3: The former distillation building in the lagoon system area

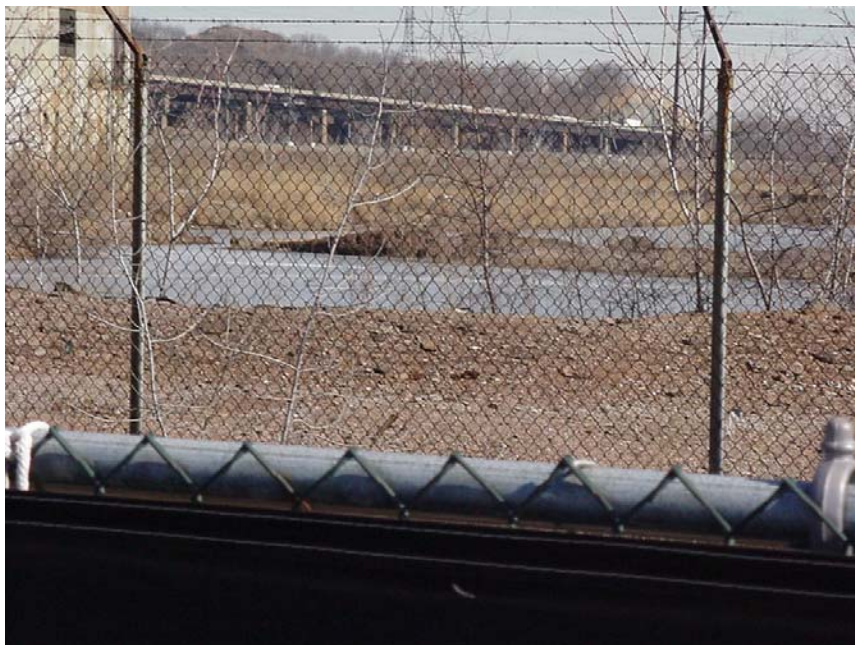
Photograph 4: The lagoon system

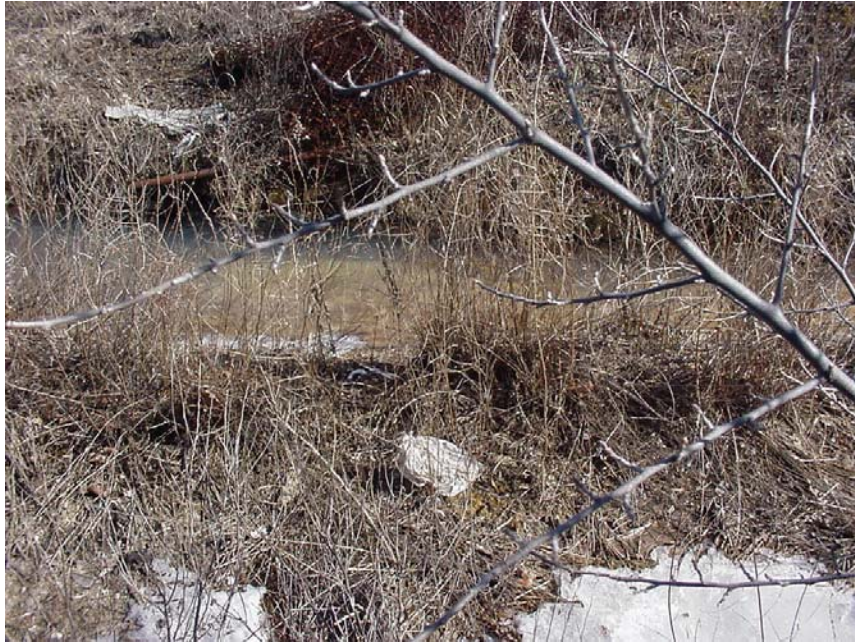
Photograph 5: Trench with standing water located inside the fenced area surrounding the lagoon system

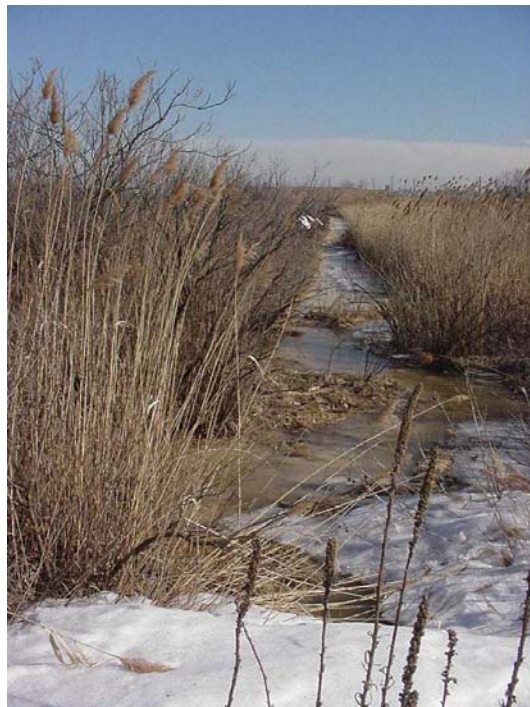
Photograph 6: The southern drainage ditch

Under New Jersey Pollutant Discharge Elimination System (NJPDES) Discharge to Surface Water Permit, Standard Chlorine was permitted to discharge septic tank overflow, boiler blow down and stormwater runoff into the southern drainage ditch. Standard Chlorine was found in violation of the Spill Compensation and Control Act and the Water Pollution Control Act as stated in the Administrative Consent Order issued by the NJDEP and signed by NJDEP and Standard Chlorine on 20 October and 18 October, 1989, respectively (NJDEP 1989). The violations were issued for the past and current discharges of hazardous substances and pollutants into the waters and onto the lands of the State of New Jersey (NJDEP 1989). Additionally, during the October 2002 USEPA sampling event, a seep was observed entering the Hackensack River from the sediment nine feet to the southeast of the outfall where the southern drainage ditch confluent with the Hackensack River. The seep was black in color with observed sediment and chemical analysis of the seep documented the presence of 1,4-dichlorobenzene (USEPA 2003).

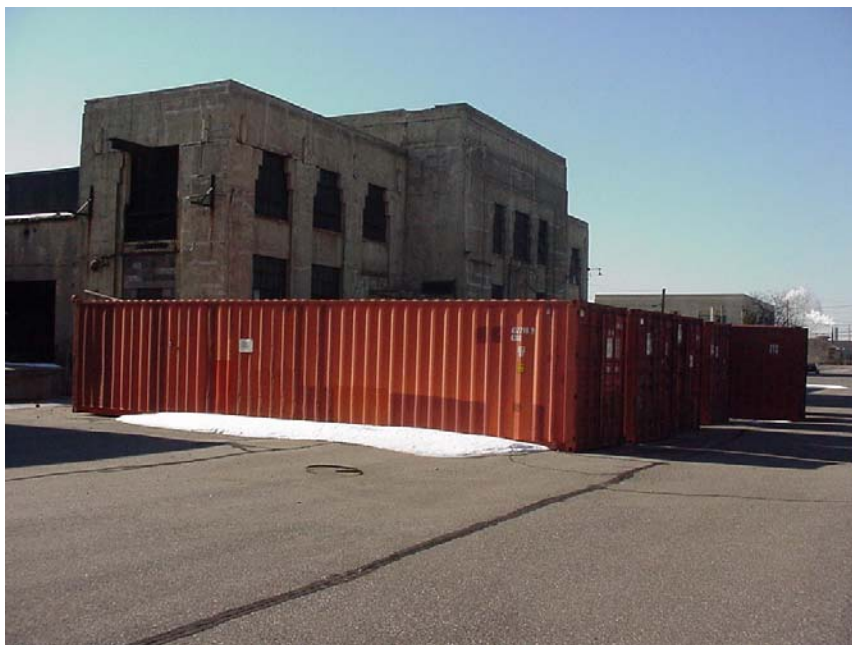
Photograph 7: Sea boxes containing dioxin-contaminated asbestos among other process wastes

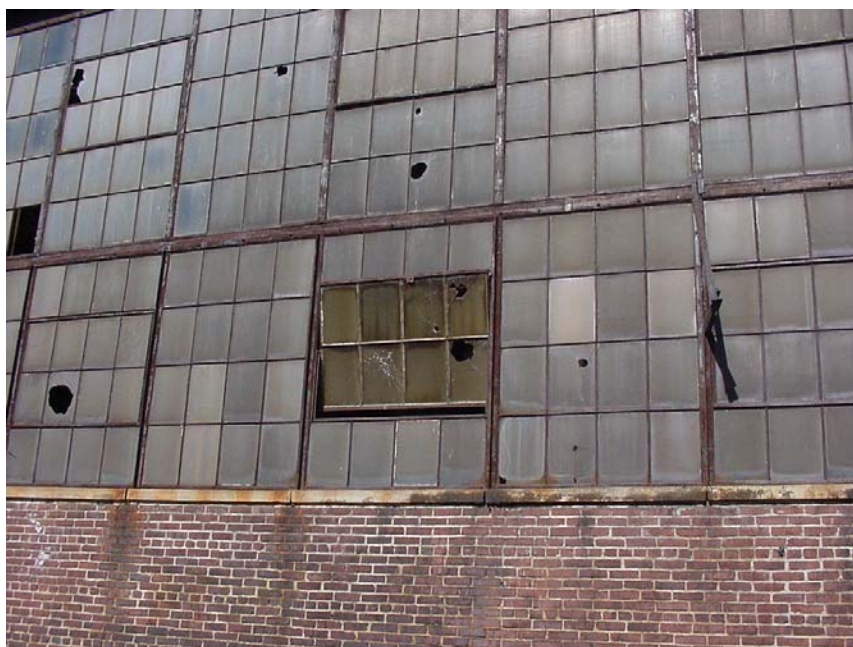
Photograph 10: Example of broken windows on the Standard Chlorine site

A small number of Standard Chlorine personnel occasionally work in the on-site office building. When asked about vandalism, they commented that it was a problem in the past, occurring primarily at night. This was evident from the numerous broken windows observed for on-site buildings, although Standard Chlorine personnel stated that wind damage accounted for some of this damage. According to Standard Chlorine personnel, individuals from various trucking companies periodically visit the site to inquire about the sale of the property. Local discussions about possible future uses for the site included light industrial warehousing (e.g., big box storage) and commercial (e.g., Walmart, Lowe's). Recreational uses of the Hackensack River adjacent to the site were not discussed during the site visit; this was discussed separately in a telephone conversation with the Hackensack Riverkeeper, Captain Bill Sheehan.

As described in the site visit section of this report, there were indications of trespassers/vandals at the Standard Chlorine site (e.g., broken windowpanes on buildings, evidence of rubbish/trash washed up on the Hackensack river bank). The potential for exposure to these individuals on a routine basis is unlikely and does not justify a completed exposure pathway designation. The nearest residential area is two miles to the west and it would require a determined trespasser to access the site from the Belleville Turnpike. The northern and the western portions of the Standard Chlorine site are fenced and gated; however, the eastern portion of the site adjacent to the Hackensack River is not secure against access from the river. Although it is unlikely that the public would utilize the Standard Chlorine shoreline for recreational purposes, it was noted in the site visit that this has happened in the past (example of an individual launching boat from the shoreline) and the possibility of unauthorized access to the site via the river cannot be dismissed.

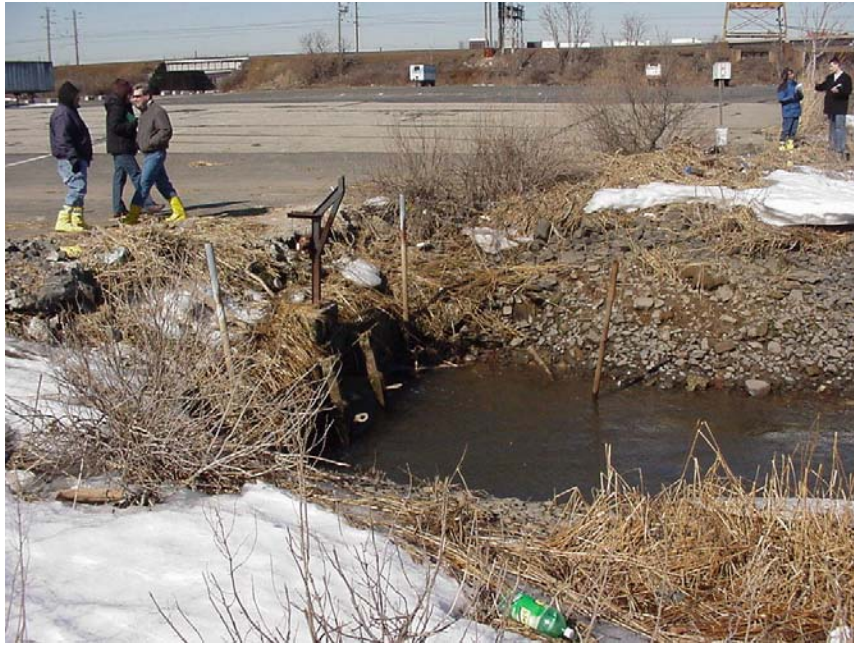
Photograph 11: The north outfall adjacent to the former Diamond Shamrock site

The Hackensack River was at low tide during the site visit. The site visit personnel proceeded to the driveway between Tierra Solutions, Inc. and Standard Chlorine and observed the north outfall into the Hackensack River from the buried storm sewer that runs along the entire northern boundary of the Standard Chlorine site. Brown green puddles, possibly indicative of chromium contaminated water, were observed on the surface of the driveway. Upwelling of the water into the driveway occurs due to the high water table, especially under wet weather conditions. Surface water, rapidly running into a sewer drain was also observed on this driveway.

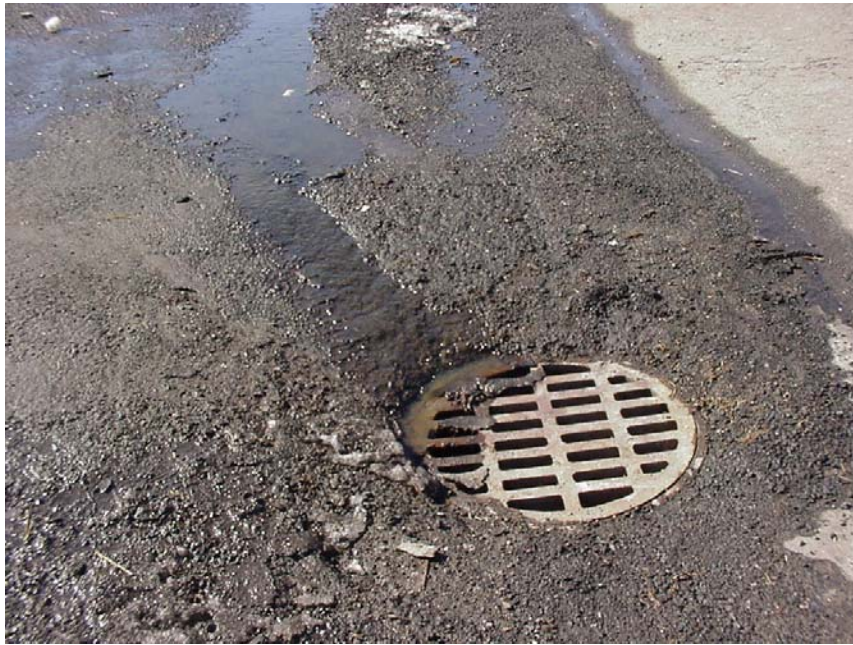
Photograph 13: Storm drain located on the driveway shared between Standard Chlorine and the former Diamond Shamrock site

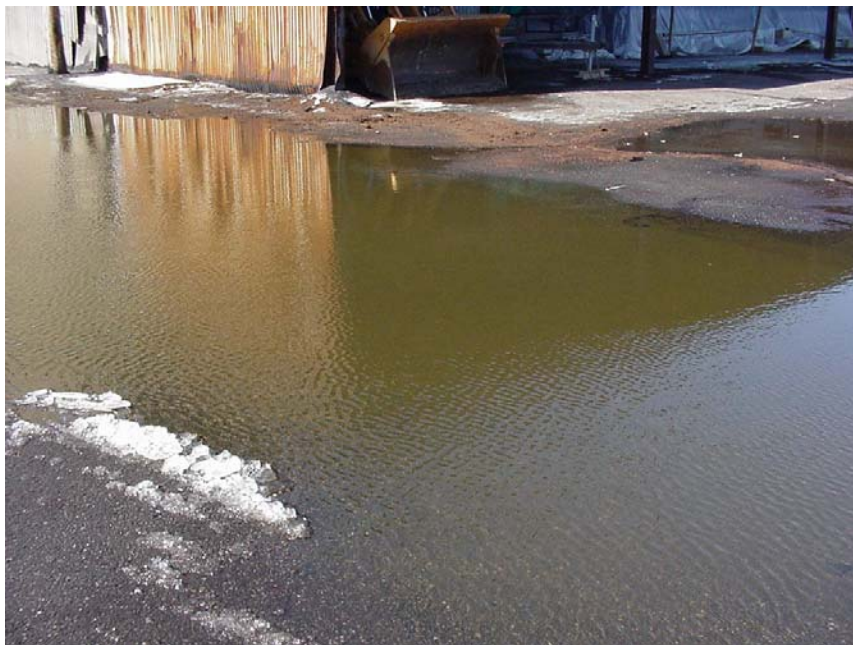
Photograph 14: Standing water as observed in the shared driveway
